Willoughby Flood Action Plan - Part 2

January 2025

CANAL FLOODING (WILLOUGHBY)

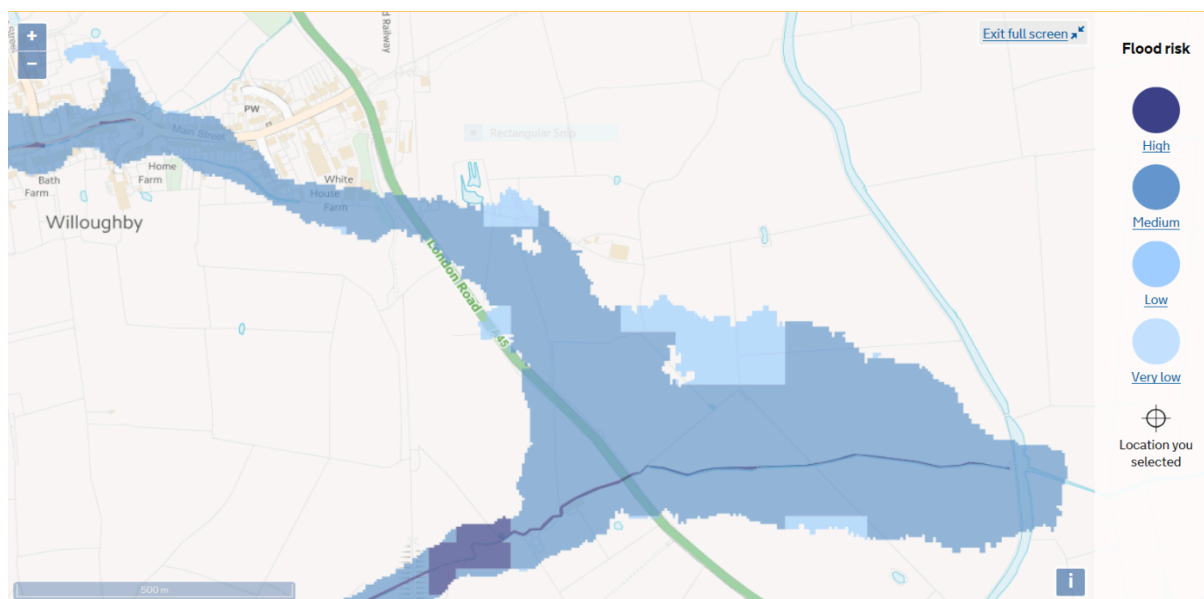
Figure 1.

Figure 1 shows the EA map for Fluvial Flooding for Willoughby. The Oxford Canal is shown to the right of the map and the source of the floodwater is overflow from the Canal. The flood water originates at MR:-SP535666 where the brook draining the Braunston Cleaves catchment flows into the Oxford Canal. A waste weir is sited on the opposite bank of the canal with a spillway into the streambed which existed before the canal was built. This stream bed routes across the fields to the east of the A45 and passes through two culverts under the A45 at MR:-SP528667. The waste weir is normally dry and the stream bed is silted and overgrown and at a meeting with British Waterways in 2014 it was stated that the weir had been out of service for the preceding ten years and reliance was on the major waste weir at Puddle Bank above the River Leam at the Severn Trent sewage facility near Braunston and which was being modified to be returned to service.

The well recorded Easter Storm of 1998 which lasted for two days resulted in canal overtopping and flooding of the fields to the East of the A45. The surplus water found its way across the A45 at the old station to be taken by the drain, installed in 1938 to keep the roadway at the station drained of flood water, behind the houses in Main Street to join the Willoughby Brook at the centre of the village. This resulted in significant flooding in the village and is the flood incident upon which the EA fluvial flood map is based.

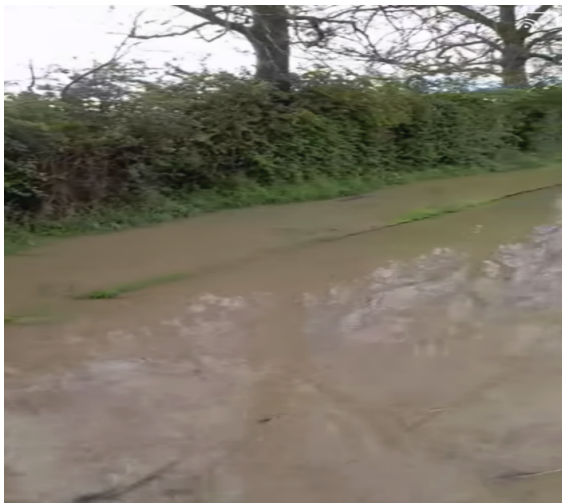
At times of sustained rainfall or severe thunderstorms the canal water level rises, flooding the towpath and overflowing the canal boundary into the fields beyond. Which is what occurred on May 9th 2023 when as result of a severe thunderstorm over the Braunston Catchment and North Daventry substantial quantities of water entered the canal resulting in overtopping in the length of canal around Bridge 88. (See photograph 1). Water cascaded into the adjacent fields.

Photo 1:- Canal overtopping at Bridge 88

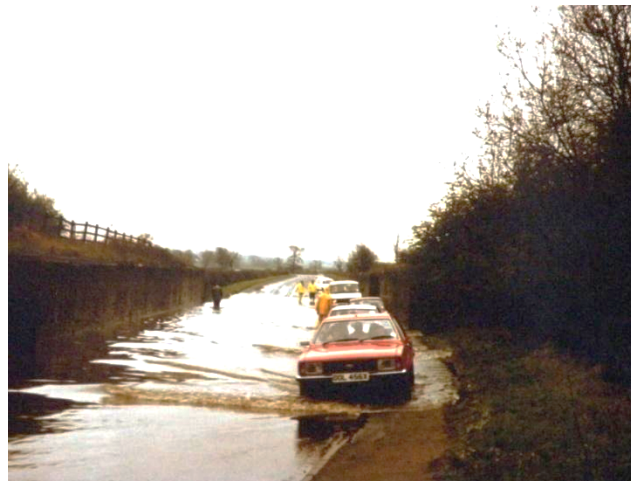
All the floodwater cannot pass through the two culverts and the surplus spreads across the adjacent fields. Because the A45 is higher than the surrounding fields the water accumulates and flows back towards the old Great Central Railway station. (The Turnpike was raised to avoid boggy ground when the road was built in the 1700's). When the GCR was built the roadway below the bridge was lowered to

provide extra clearance allowing the floodwater to build up on the roadway and flow diagonally across the road to bring floods into the village of Willoughby. (See photograph 2)

Photo 2:- A45 Flooded by Canal water off fields to East of Road (Old Station Bridge)

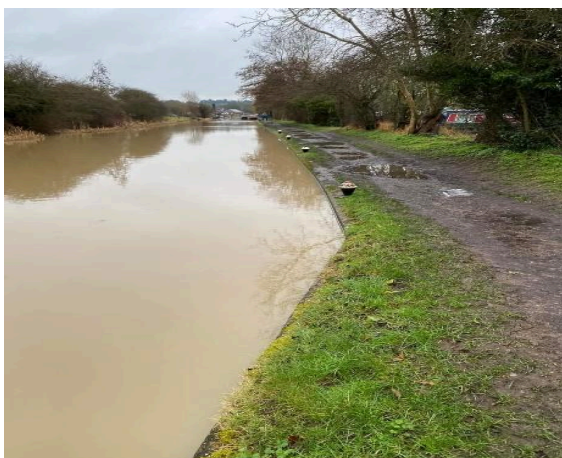
On February 18th 2024 the Willoughby Brook level rose early morning around 5am and was over road in lower Main Street by 7.30am. It was short lived and the level was falling by 8.45am. An early morning observer reported seeing fields flooded adjacent to canal overflow drain at A45 and another walker reported still high flow in Willoughby Brook under A45 later in day and queried if this might be due to canal overtopping. The canal was described as excessively high on social media and photographs of the canal overtopping the towpath towards Flecknoe are shown (Photograph 3). Comments by canal related people in criticism of design of Puddle Bank waste weir which is clearly inadequate to handle flows required to maintain the Oxford Canal within its banks. If the Affinity Project goes ahead this is an aspect of canal design which must be addressed.

Photo 3 :- Oxford Canal topping banks towards Flecknoe

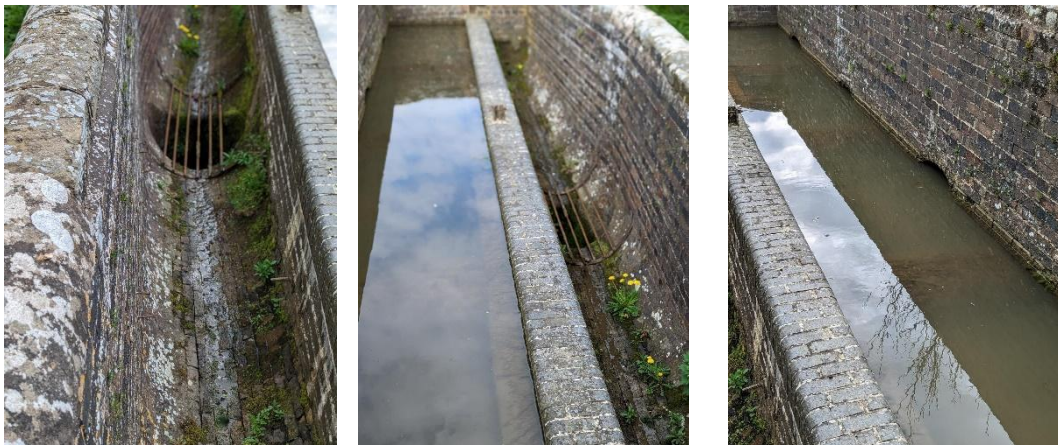
Puddle Bank Waste Weir Design

The Puddle Bank Weir is a vintage design introduced well before modern sluice and gate barriers were introduced. Four culverts are capable of passing water from the canal to a chamber some 25 feet long. The water is held back by a weir wall which presents a barrier to the water in the canal and when the water is level with the lip of this weir represents normal canal level. As the canal level rises during a flood the water level rises above the lip of the weir and the run-off is proportional to the depth of water above the weir lip. The water flow is limited by the quantity of water that the culverts can pass.

With the inevitable increase in rainfall resulting from climate change this facility, which is already unfit for purpose, will need to be replaced with a modern sluice gate with a three term control facility which maintains the level in the presence of increasing flow of water into the canal. The size of the overflow is insufficient to meet future needs and the use of a single major overflow is questionable. A distributed approach to overflow is probably required. A much more sophisticated technique will be required if the Affinity Water Project goes ahead.

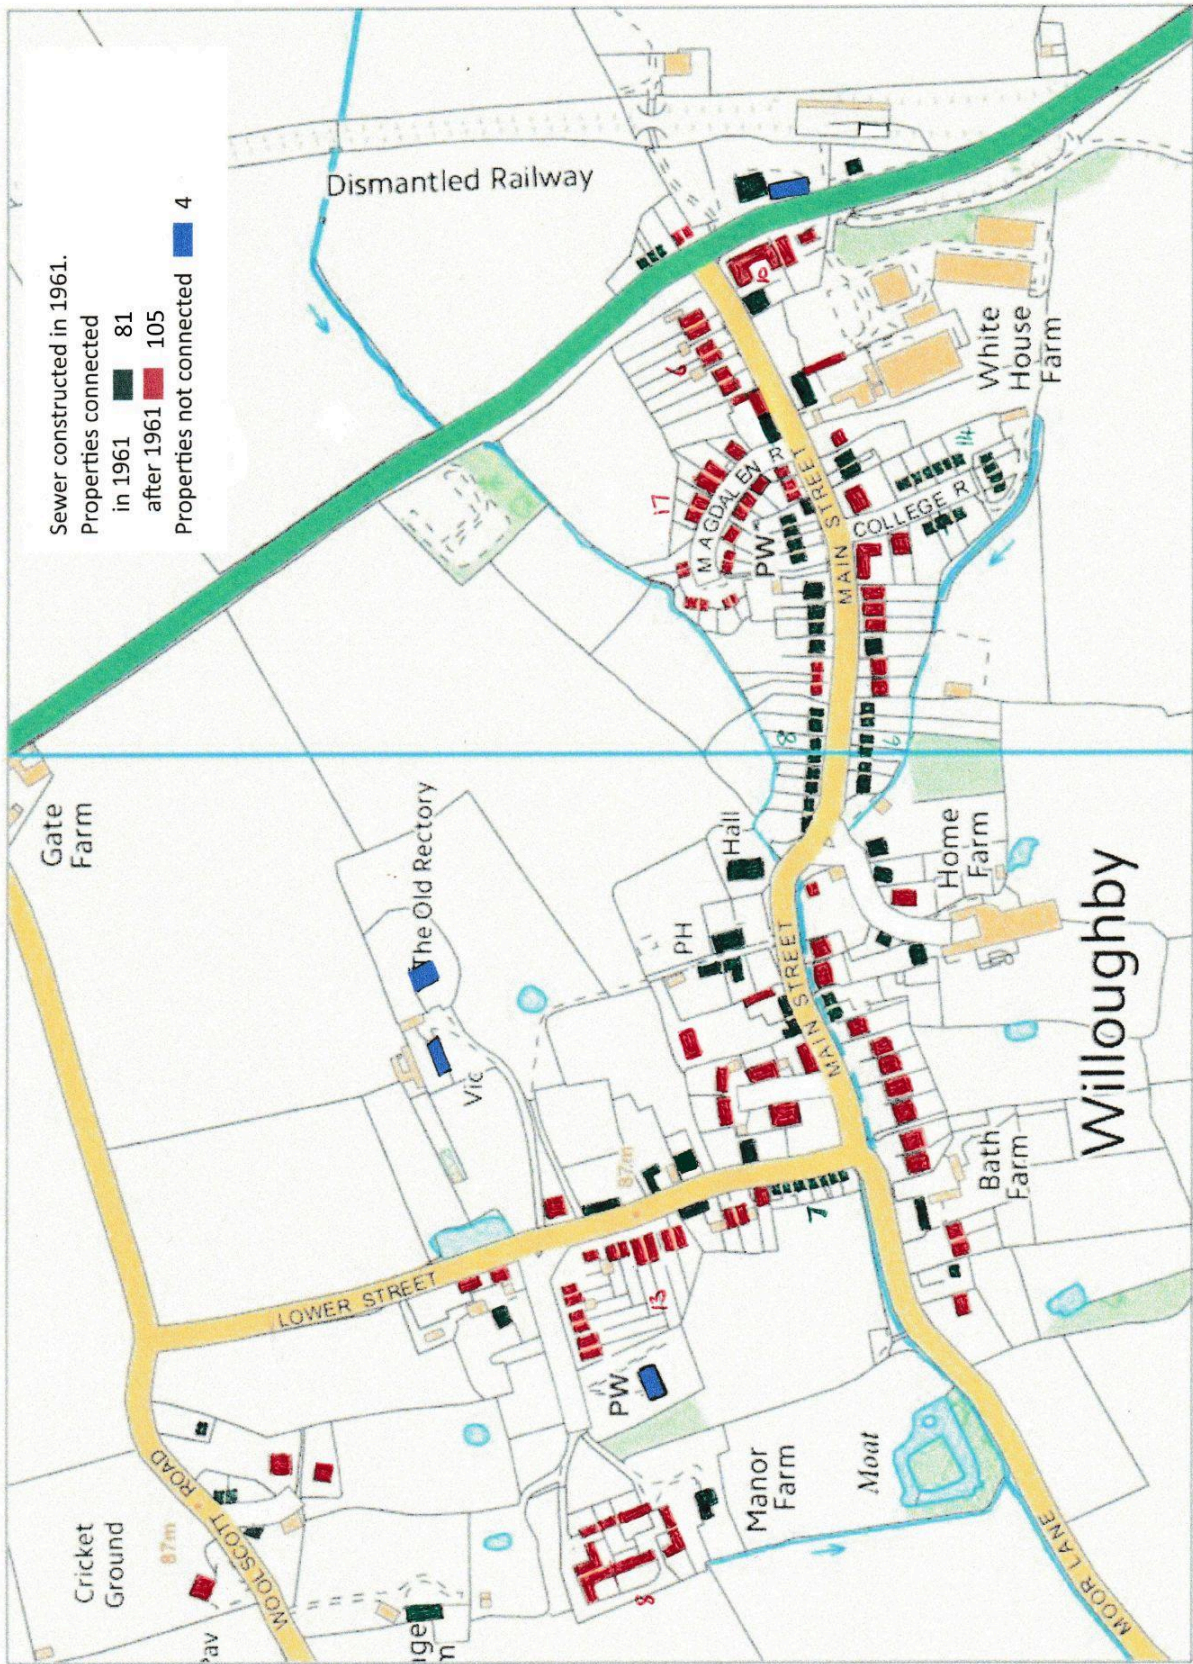
Appendix B. Sewerage System - Properties built before and after 1961

The main sewer in the village was constructed in 1961. A plan has been produced showing the number of properties that existed in 1961 (81) and the number built afterwards (105). The sewer is a combined sewer into which most properties discharge both sewage and rainwater. This leads to overloading of the sewer during periods of sustained rainfall and the lifting of inspection chamber covers so that sewage overflows into floodwater creating a significant environmental and health hazard.

FLAG proposes to contact Severn Trent Water to see if it would be possible to increase the capacity of the sewer to prevent the current situation during flooding events. Cllr Dale Keeling has a contact at Severn Trent and has said he will raise our situation with him.
